**Assessment report:** State of the wooden construction, fresh water marina, Akkrum

**Report code:** 20.0382

**Date:** December 11<sup>th</sup>, 2020

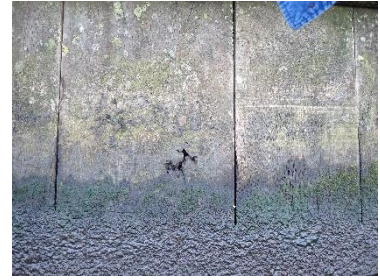
Sheet piles 1a, okan, start from the 25<sup>th</sup> sheet pile along the main river pathway (after the corner with the combination sheet piles, no. 3), thickness 40 mm, width 255 mm, 26<sup>th</sup> sheet width 155 mm, following sheets with variable width. Interlocked grain, fine wood structure, compared to all other sheet piles it is remarkable that there was almost no algae, mosses or plant growth; good condition (visually no decay and density profiles show weak decay only in outermost parts on top landside 15 mm, lower at waterside 10 mm). 27<sup>th</sup> sheet is sampled (M4) and density profiles were made.

Remarkable little attached growth of algae and mosses

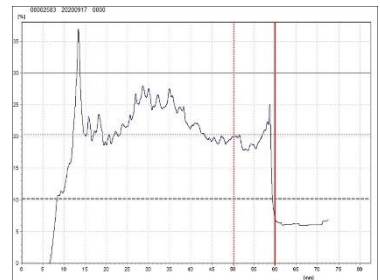
2505: no significant decay only weak decay landside 15 mm

2504: thickness 40 mm; no significant decay only weak decay waterside 10 mm

2503: no significant decay only weak decay waterside 10 mm

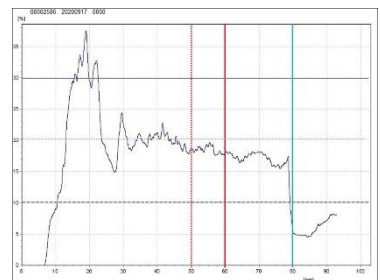
Sheet piles 1b, azobé, starts after sheet piles 1a and have variable widths of 240, 310, 320 and 340 mm. They have interlocked grain, fine wood structure, condition good (no visible decay, density profiles show only weak decay top 10 mm at landside, middle 10 mm at waterside and water level 5 mm in middle). 27<sup>th</sup> sheet is sampled (M5) and density profiles were made.

2508: no significant decay only weak decay landside 10 mm

2507 thickness app. 50 mm, no significant decay, only weak decay waterside 10 mm

2506: no significant decay, only weak decay behind a thin hard layer in 5 mm

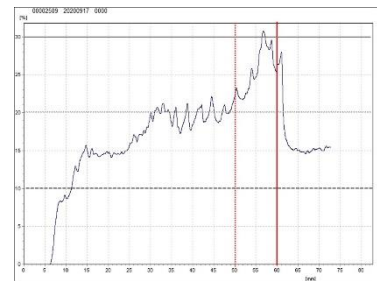
Condition relative good (visible/ awl at top pile landside 5 mm decay, density profiles show only weak decay in the middle parts, most prominent in the upper 250 mm); the same sheet pile is sampled (M6) as from which the density profiles were made.

2509: no significant decay, only moderate decay waterside 5 mm and weak decay middle 20 mm  
WL just above water level (water side)

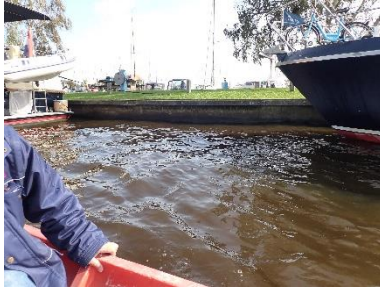
Sheets piles 1d, tali, next after 1c sheet piles are located between pole 15 and 16. Thickness at least 40 mm. Condition relative good (visual no decay, density profiles moderate decay 10 mm deep waterside from 150 mm downwards, weak decay landside 5-15 mm top to water level, and middle top to 300 mm downwards 15 mm); the same sheet pile is sampled (M7) as from which the density profiles were made.

2527: no significant decay, only weak decay landside 5 mm and middle 15 mm

2521 thickness more than 40 mm; moderate decay waterside 10 mm, weak decay landside 15 mm and middle 15 mm

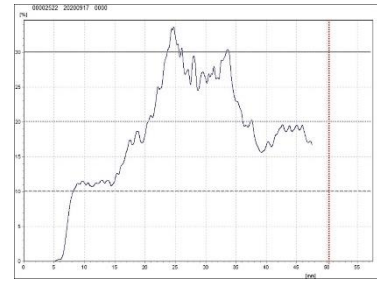
2522: moderate decay waterside 10 mm, weak decay landside 15 mm rest no significant decay

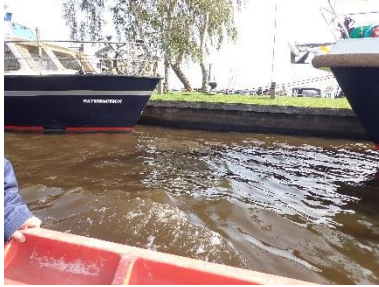
Sheet piles 1e, okan, next few sheets piles after 1d sheet piles are located around pole 13. Thickness 50 mm. Condition relative good (visual, awl at top landside 1-2 mm decay, density profiles show weak decay in the middle and at the top landside 20 mm, and at the water level waterside 15 mm); the same sheet pile is sampled (M8) as from which the density profiles were made.

2532: weak decay landside 20 mm and middle 10 mm, rest no significant decay

2533 thickness app. 50 mm; weak decay waterside 15 mm and middle 20 mm, rest no significant decay

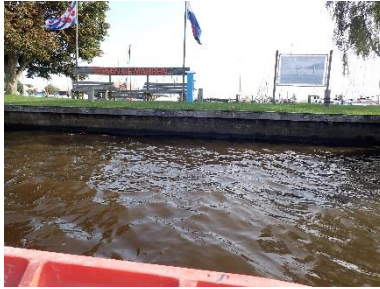
Sheet piles 1f, tali, next few sheets piles after 1e sheet piles are located around pole 9. Thickness 50 mm. Condition is good (density profiles show weak decay at waterside over whole length in 5 mm, and at the top in the middle 5 mm). The same sheet pile is sampled (M9) as from which the density profiles were made.

2534: no significant decay, only weak decay landside 5 mm, middle 5 mm (behind hard peal waterside)  
AB upper part (land side, approximately 15 cm from head)

2535 thickness app. 50 mm, no significant decay, only weak decay waterside 5 mm  
HV just below purlins (water side, 30 cm from head)

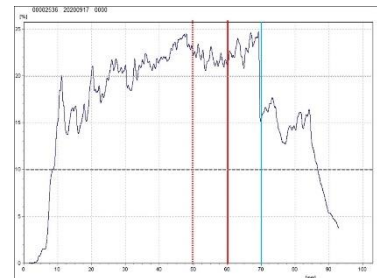
2536: no significant decay, only weak decay behind hard peal waterside 5 mm  
WL just above water level (water side)

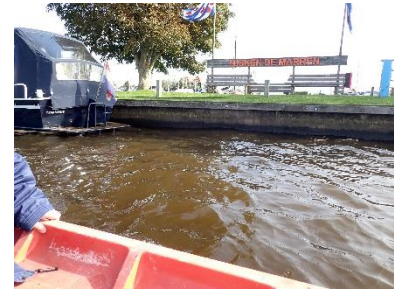
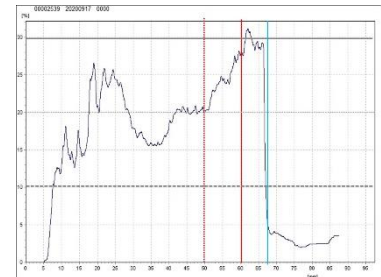
Sheet piles 1g azobé, next few sheets after 1f sheet piles are located around pole 7. Thickness 50 mm. condition questionable (visual / awl top landside white rot 30 mm deep, density profiles show moderate decay in the upper 300 mm at the landside 10-20 mm and in the middle part 15-25 mm, at the water level the decay is less weak); the same sheet pile is sampled (M10) as from which the density profiles were made.

2538 thickness app. 50 mm, decay moderate landside 20 mm, moderate -severe middle 15 mm, rest (waterside) no significant decay 25 mm

2539: weak decay waterside 10 mm, middle 35 mm, rest (landside 15 mm) no significant decay

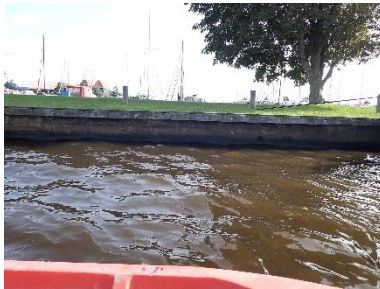
Sheet piles 1h, araracanga, next few sheets after 1g sheet piles are located around pole 5. Thickness 50 mm. Condition good (visual / awl top landside superficial decay, density profiles no significant decay, only weak decay at top both land-and waterside in 5 mm, and at the water level waterside 10 mm and middle 20 mm); the same sheet pile is sampled (M11) as from which the density profiles were made; this is the last pile of this species.

2540: no significant decay, besides weak decay landside behind hard peal 5 mm, waterside 5 mm.

2542 thickness app. 50 mm, no significant decay

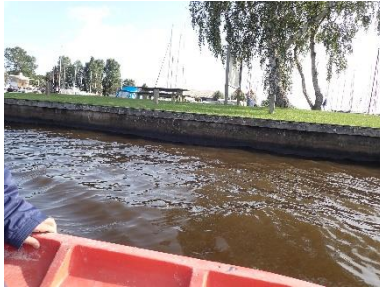
Thickness 50 mm. Condition bad (visual / awl top landside deeply degraded, density profiles show moderate to severe decay in large parts of the pile); the same sheet pile is sampled (M12) as from which the density profiles were made, is the first pile of this species.

2541: decay moderate to severe over whole thickness.

2543 thickness app. 50 mm, decay moderate landside 20 mm, middle 20 mm, rest weak of no significant decay just below purlins (water side, 30 cm from head)

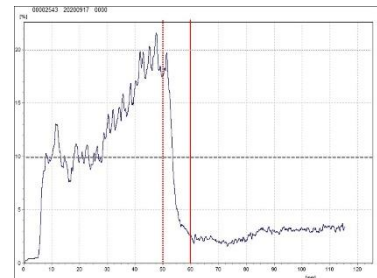
2545: moderate to severe decay waterside, moderate decay middle 20 mm, weak decay landside just above water level (water side)

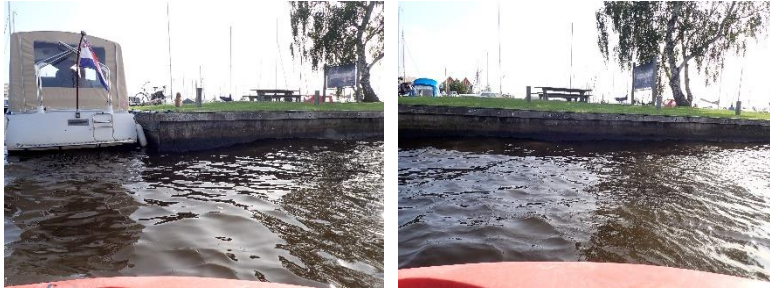
Sheet pile of okan

Sheet piles 1j, okan, next few sheets after 1i sheet piles are located near pole 1. Thickness 50 mm.

Condition bad (visual / awl top landside 50 mm decay, waterside no significant decay, density profiles show moderate decay in large parts of the pile); the same sheet pile is sampled (M13) as from which the density profiles were made.

The sheet pile left of that last one is another species and its condition better (density profiles show moderate decay throughout the whole thickness in the middle part, top only weak decay landside 10 mm and at water level moderate decay landside 10 mm and weak decay waterside 15 mm).

2546: decay moderate to severe over whole thickness.

2548: decay moderate to severe over whole thickness

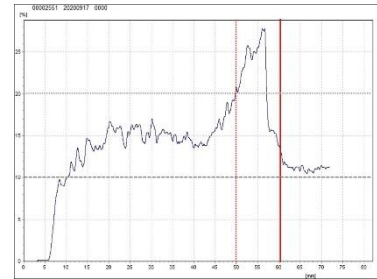
Sheet piles near the corner of the island

2551 thickness app. 50 mm, decay moderate 45 mm, only weak -no decay landside 5 mm

2547: no significant decay, only weak decay landside 10 mm

2552: moderate decay, weak or no decay landside 5 mm

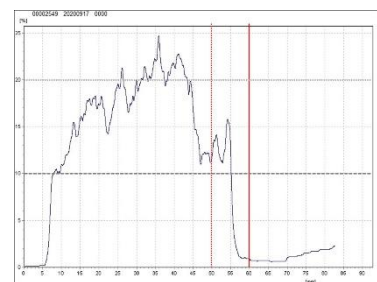
2549: moderate decay landside 10 mm, weak decay waterside 15 mm, rest no significant decay

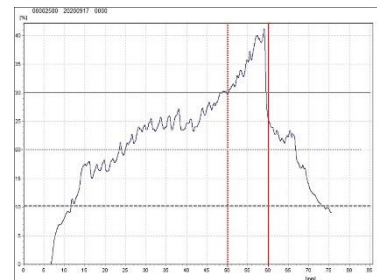
Sheet piles 2, angelim vermelho, the first 24 sheets piles along the main river pathway after the corner with the combination sheet piles 3. It is assumed that the lower parts of the sheet piles is Austrian larch, thickness 45 mm, width approximately 180 mm, rabbet 20 x 20 mm. The condition of the piles is good (no visible or with density profiles detectable decay), third sheet is sampled (M3) and density profiles were made.

2502: no significant decay both water and landside

2501: thickness is app 45 mm, no significant decay both water and landside

2500: no significant decay only 5 mm weak decay waterside

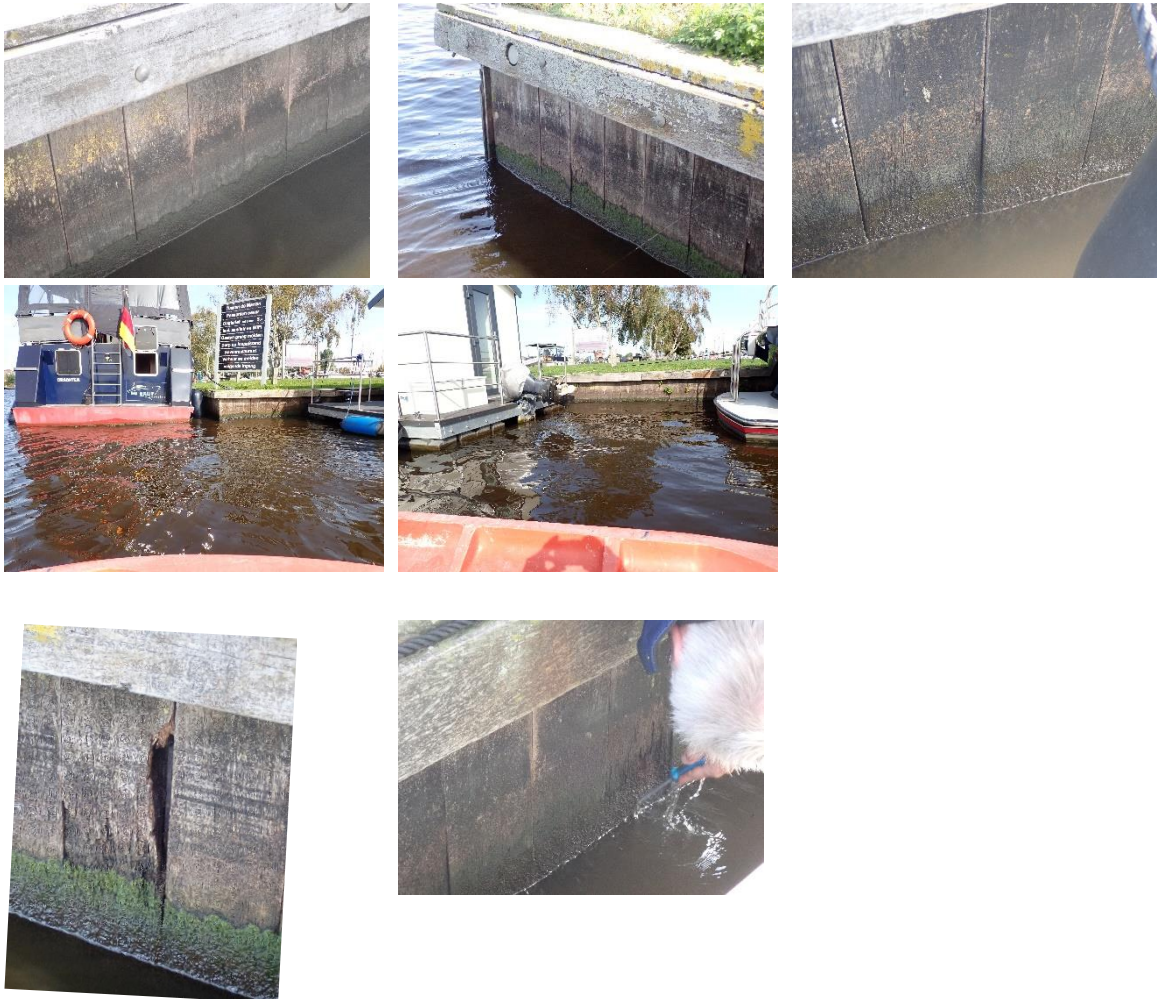
Sheet pile 3, combination sheet pile (Van Swaay), situated over the full short end of the island. The upper part is angelim vermelho, thickness 45 mm, width approximately 180 mm, rabbet depth 20 mm, 22 mm wide and the lower part is probably a softwood. Most upper parts are sound, no decay, a few upper parts show some bugling and occasionally some plant growth through the nails.. The condition of the eighth sheet from the corner with the frontside of the island, was questionable (visually degraded, density profiles show weak to moderate decay on waterside at middle) (M1, lost its smell), adjacent sheet was good (visually no decay, density profiles show weak decay in top 15 mm on landside, 10 mm middle), (M2). Both samples confirm the wood species.

2498: landside no significant decay, weak decay middle 25 mm, moderate decay waterside 10 mm

2495: no reliable thickness estimation here because of skewed measurement; landside no significant decay, weak decay middle 10 mm, moderate decay waterside 25 mm

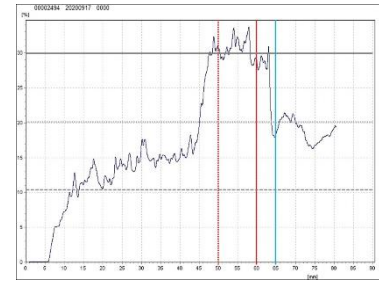
2494: landside no significant decay, weak decay in middle and waterside 35 mm

Degraded sheet (M1)

Sheet pile with no visual degradation (M2)

2499: landside weak decay in 15 mm, 10 mm in middle, rest no significant decay

2497: no reliable thickness estimation here because of skewed measurement; weak decay in middle 10 mm, rest no significant decay  
just below purlins (water side, 30 cm from head)

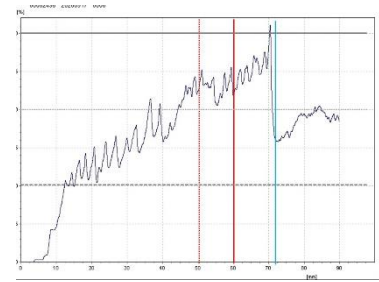
2496: no significant decay for both water and landside  
just above water level (water side)

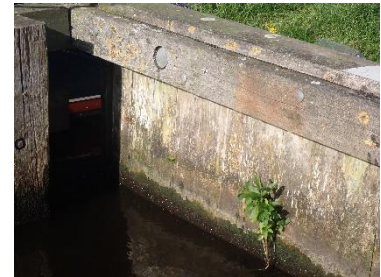
Sheet pile 4a, a combination sheet pile with Accoya

Approximately 39 combination sheet piles with Accoya, thickness 53 mm, width 132 mm, moisture content (at density 0,65 g/cm<sup>3</sup>) both land and water side 20-35%, no detectible decay, finger joints to the supposed lower spruce part were not detected (between cross surface Accoya and decking at least 5 mm space, some plant grow between the beams).

2493: no significant decay both water and landside

2491: no reliable thickness estimation here because of skewed measurement; no significant decay both water and landside

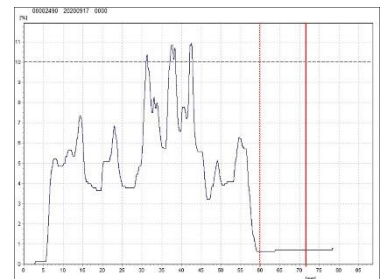
2490: no significant decay both water and landside

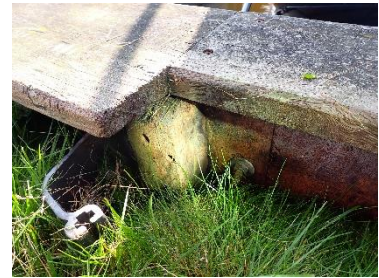
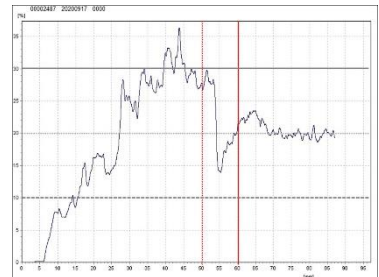
Sheet pile 4b, three combination sheet piles softwood with an upper part of angelim vermelho (specific smell), thickness 53 mm, width 178 mm, rabbet depth 24 mm, moisture content (at density 0,90 g/cm<sup>3</sup>) landside 14%, waterside high 20-21%, in good condition (only some weak decay in 10 mm landside top; 15 mm waterside and 5 mm middle; 20 mm waterside and 2 mm middle on water level). Finger joints to the supposed lower spruce part were not detected visually or as an uneven connection.

2492: landside weak decay in 10 mm, rest no significant decay

2488: waterside weak decay in 15 mm, 5 mm in middle, rest no significant decay

2487: waterside weak decay in 20 mm, 2 mm in middle, rest no significant decay

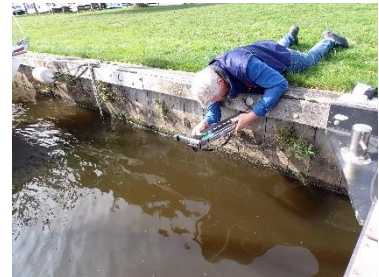
Sheet piles 9, reused azobé sheet piles. Thickness 50 mm. Condition good (visual / awl top landside superficial decay, density profiles no significant decay, only weak decay at top both land-and waterside in 5 mm, and on the water level waterside 10 mm and middle 20 mm); the same sheet pile is sampled (M16) as from which the density profiles were made, is the last pile of this species. Cover plank severely degraded with many ants.

2556: no significant decay, besides weak decay landside behind hard peal 5 mm, waterside 5 mm.  
upper part (land side, approximately 15 cm from head),

2557 thickness app. 50 mm, no significant decay  
just below purlins (water side, 30 cm from head)

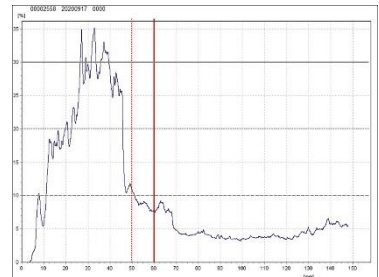
2558: weak decay waterside 10 mm, middle 20 mm, rest no significant decay  
just above water level (water side)

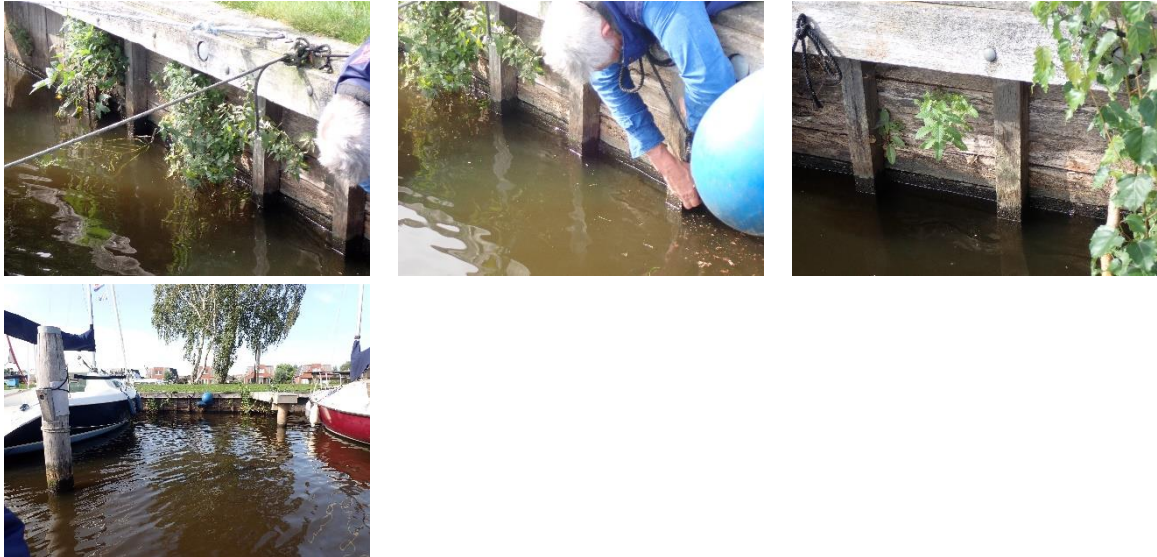
Location 10, robinia bulkhead and kopie (cupiuba) poles. Condition poles good (visual / awl above water part is hard), bulkhead bad (severe decay), wood sample M15. Extensive plant growth was seen.

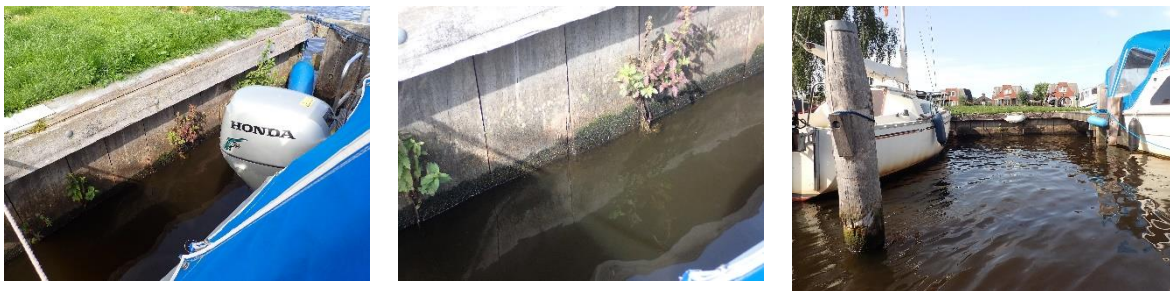
Sheet piles 11, azobé, sheets are a supposed continuation of the reused azobé under 9 until the corner of the island. Thickness 40 mm. Some plants grow through the seams, wall is coherent. Condition questionable (visual / awl waterside hard, landside not reachable, density profiles show moderate decay in upper part and in lower parts weak decay land- and waterside 5-10 mm; the same sheet pile is sampled (M14) as from which the density profiles were made, is the last pile of this species.

2553: weak decay over the full thickness, hard peal waterside.

2554 thickness app. 40 mm, no significant decay, only weak decay land- and waterside 5 mm, HV just below purlins (water side, 30 cm from head)

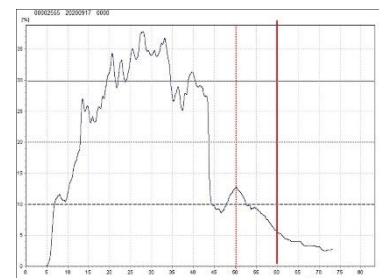
2555: no significant decay, only weak decay land- and waterside 10 mm  
WL just above water level (water side)

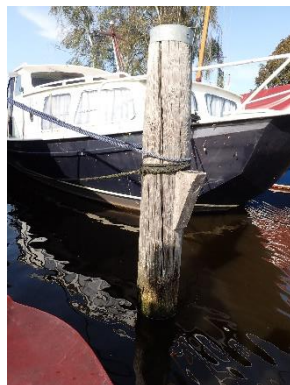
Third pole west from the entrance landing stage, larch

Round softwood pole, above the water line, one large crack and some small cracks, no significant fungal decay. On the water air line 10-20 mm decay, below the water surface sound. Wood sample (MP1) was taken.

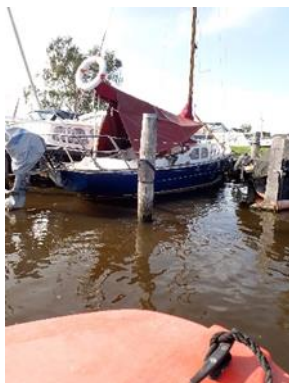
Fifth pole (MP2)

Round hardwood pole, no significant decay on and above the water line. Diameter poles approximately 22 cm. The density profile taken approximately 20 cm above the water line, shows a degraded outer most sheet of 20-30 mm. Wood sample (MP2) was taken.

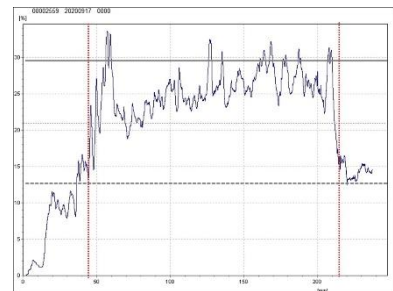
11<sup>th</sup> and 10<sup>th</sup> pole left from the entrance landing stage

Adjacent poles (7<sup>th</sup>, 8<sup>th</sup>, 9<sup>th</sup>, 10<sup>th</sup>, 11<sup>th</sup> and 12<sup>th</sup> from the entrance landing stage), cloesiana. Similar in species and decay as the fifth pole. From pole 7<sup>th</sup> a wood sample (MP3) was taken

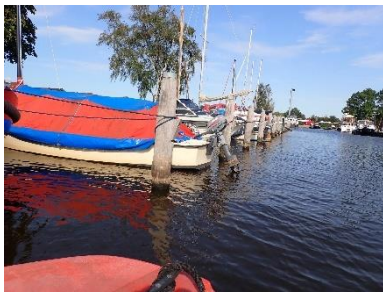
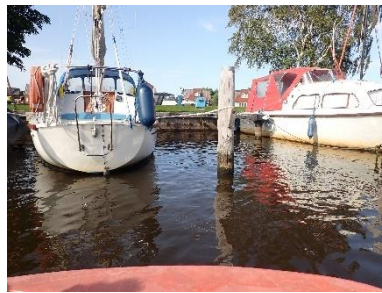
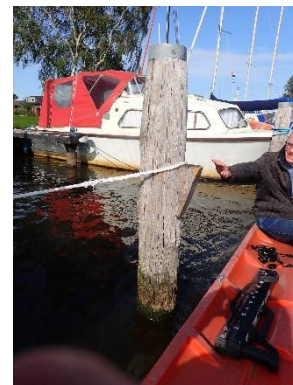
Round hardwood poles, diameter 24 cm in the part above the water level with many cracks perpendicular to the fibre angle, many small holes (< 1 mm in diameter longitudinal or cross cut) of pinhole borers, further no significant decay, wood sample (MP4).

Left picture: poles at the right of but close to the entrance landing stage, middle and right pictures: 3<sup>rd</sup> pole from which sample MP4 was taken

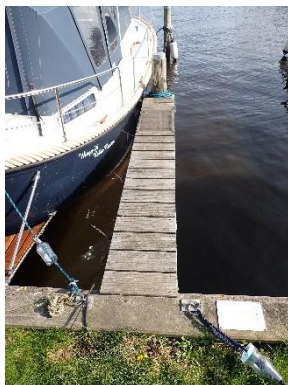
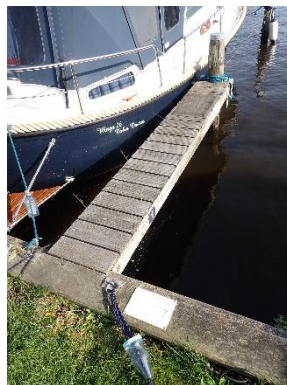
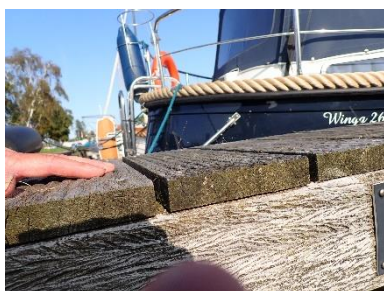
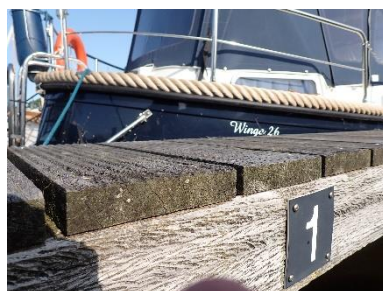
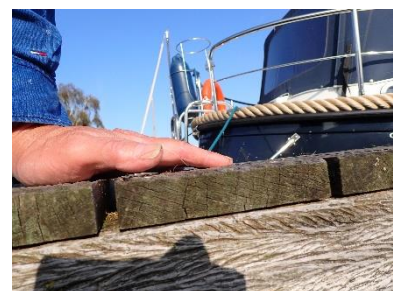
Landing stage 1 padoek in both gang boards and horizontal construction.  
Condition good, sample taken from gangboard (S4), species confirmed

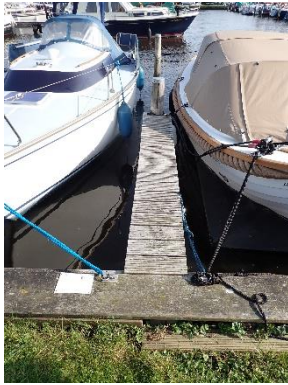
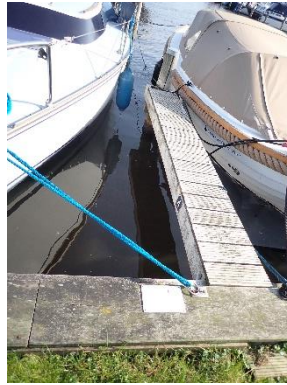
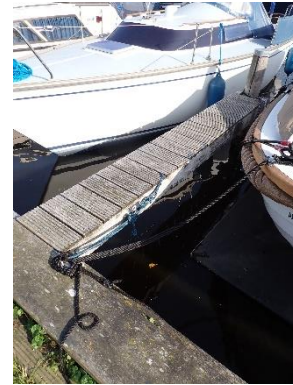
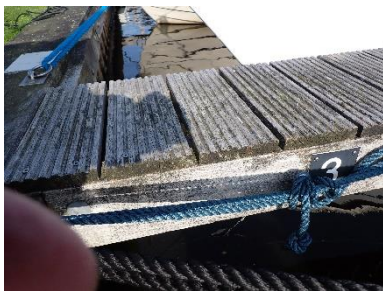
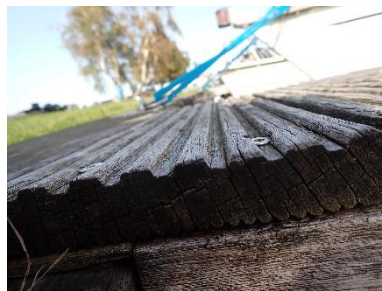
Landing stage 2 *Terminalia* species in both gang boards and horizontal construction, pole probably larch.

Condition good, sample taken from gangboard (S3).

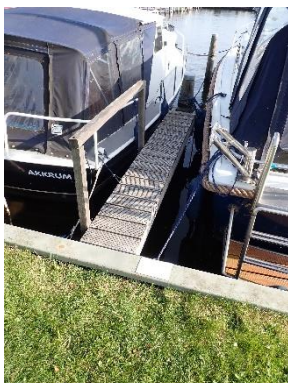
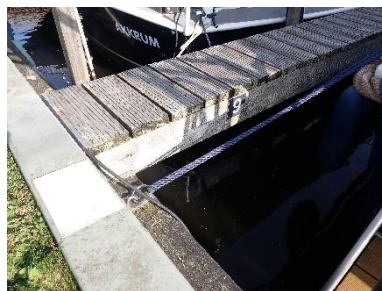
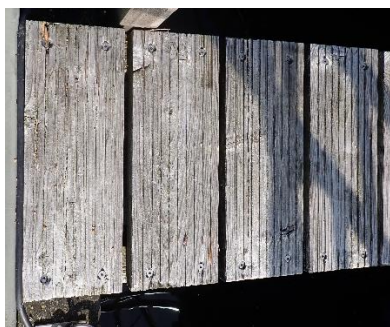
Landing stage 5 larch in all, gang boards, horizontal construction beams and pole. The gangboards are positioned with the heart side above, always. The gang boards and the horizontal construction beams are approaching their end of life stage, because of decay. In the gang boards the decay is mainly around the screws (especially at the 1<sup>st</sup>, 7<sup>th</sup>, 14<sup>th</sup>, 15<sup>th</sup>, 16<sup>th</sup>, 17<sup>th</sup> and 18<sup>th</sup> gang board). Because of the degradation, the screw connection is less tight and all boards can move somewhat compared to the horizontal beams. Also decay is found in the horizontal beams, where it is local and extending from the horizontal surface downwards. The condition of the pole is good above and below the water line, on the water line a 5 mm thick layer of weak decay is present only.

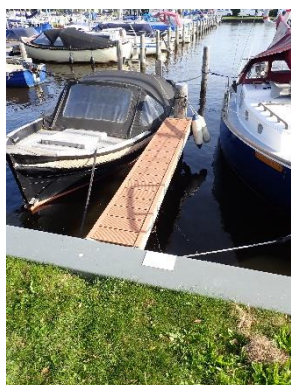
Landing stage 6 with bamboo composite gang boards

According to the harbour manager the original boards were replaced after six years. As the new gang boards are not made of wood, they were not inspected.

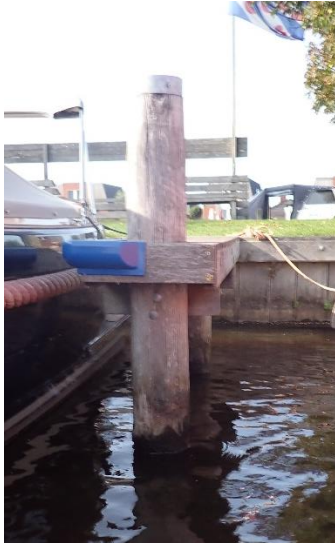
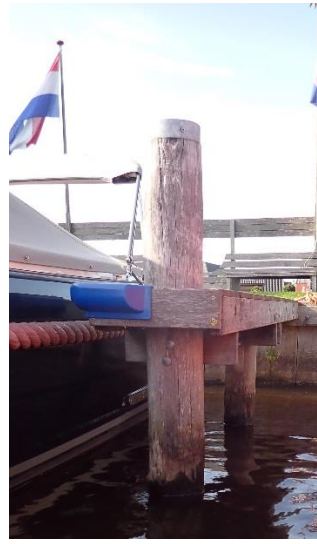
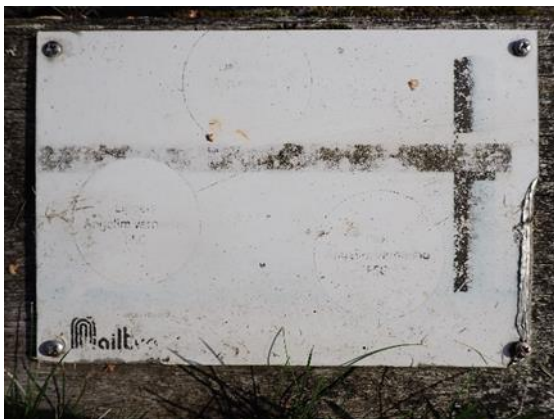
Landing stage 7 gangs boards are bamboo and two larch round poles.

The condition of the gang boards, horizontal beams and the poles are good. Sample is taken from the gang boards (S2).

Sign with landing stage seven turns out to be incorrect. The gang boards are made of bamboo and not of tanimbuca (= gindya udu), and the horizontal construction of angelim vermelho.

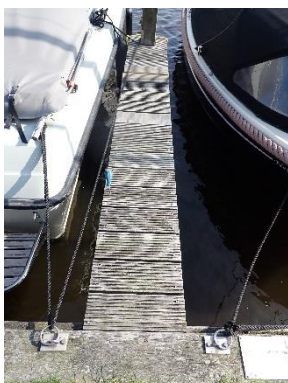
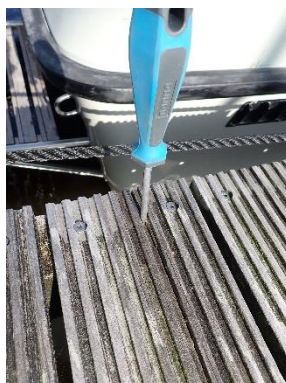
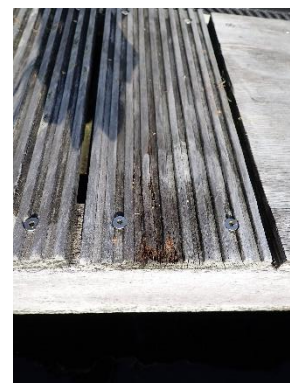
The condition of the gang boards is not good, half of them are severely degraded from the cross surface onwards or already replaced, and in the other half there is some decay around the screws.

The condition of the pole and the horizontal beams are good.

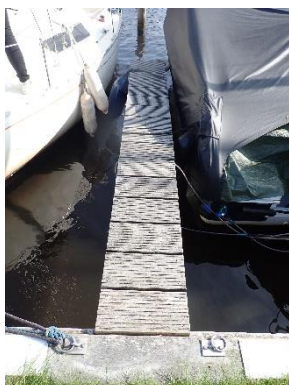
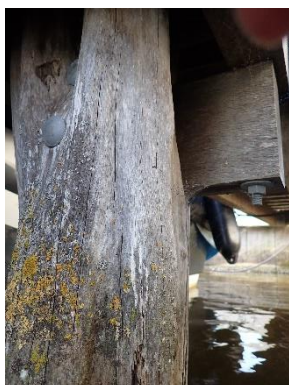
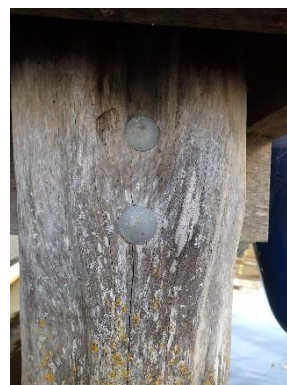
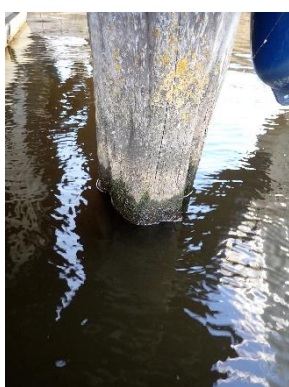
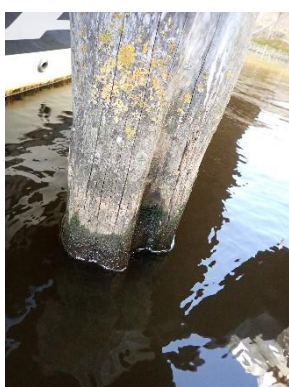
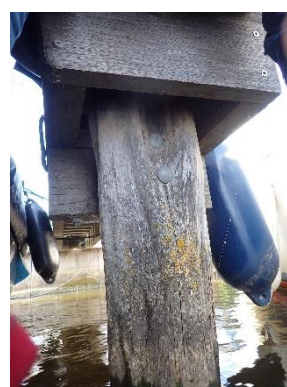
Landing stage 13 gangs boards of several species (manbarklak, angelim pedra, aldina, faveira amargosa), horizontal construction beams based on the goms flecks identified as angelim pedra, and the acariquara pole with the original tree trunk shape (non-machinable, e.g. non sawn). The condition of gang boards, horizontal construction beams and pole is good.

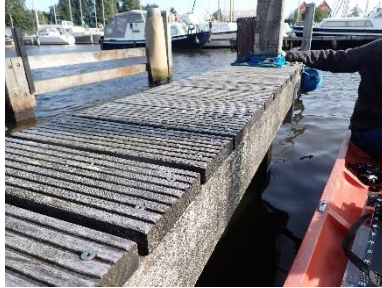
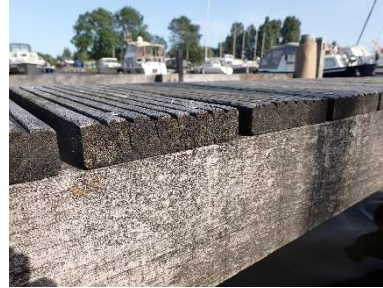
Landing stage 14 gang boards, horizontal construction beams and a sawn pole are all azobé. The condition of the gang boards, horizontal construction beams and pole is good.
