**Assessment report:** State of the wooden construction, fresh water marina, Akkrum

**Report code:** 20.0382

**Date:** December 11<sup>th</sup>, 2020

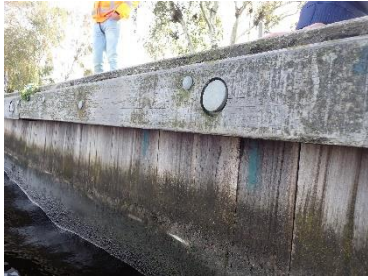
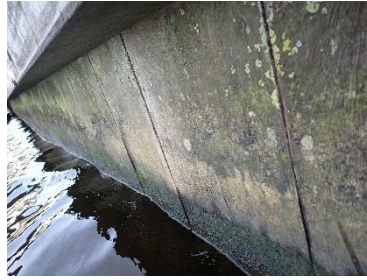
Sheet piles 1a, okan, start from the 25<sup>th</sup> sheet pile along the main river pathway (after the corner with the combination sheet piles, no. 3), thickness 40 mm, width 255 mm, 26<sup>th</sup> sheet width 155 mm, following sheets with variable width. Interlocked grain, fine wood structure, compared to all other sheet piles it is remarkable that there was almost no algae, mosses or plant growth; good condition (visually no decay and density profiles show weak decay only in outermost parts on top landside 15 mm, lower at waterside 10 mm). 27<sup>th</sup> sheet is sampled (M4) and density profiles were made.

Remarkable little attached growth of algae and mosses

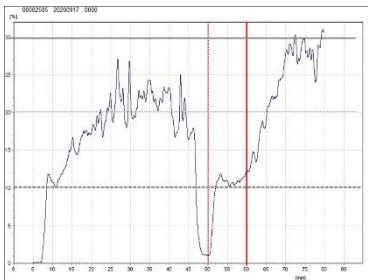
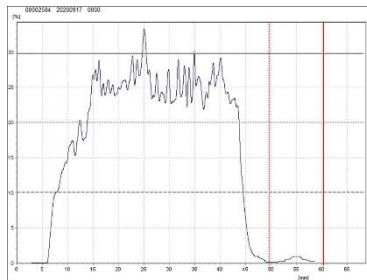
2505: no significant decay only weak decay landside 15 mm

2504: thickness 40 mm; no significant decay only weak decay waterside 10 mm

2503: no significant decay only weak decay waterside 10 mm

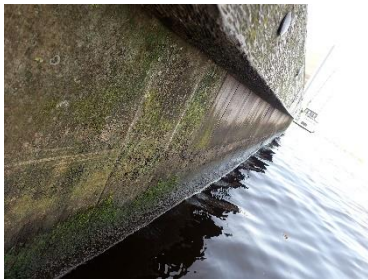
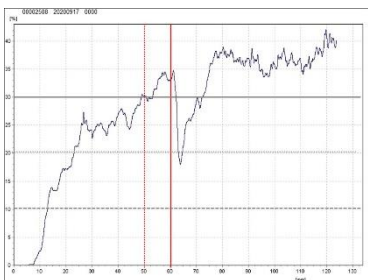
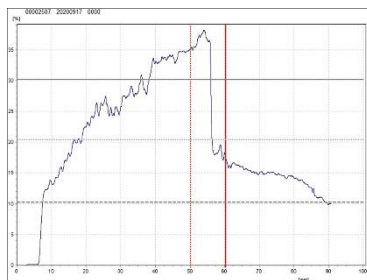
Sheet piles 1b, azobé, starts after sheet piles 1a and have variable widths of 240, 310, 320 and 340 mm. They have interlocked grain, fine wood structure, condition good (no visible decay, density profiles show only weak decay top 10 mm at landside, middle 10 mm at waterside and water level 5 mm in middle). 27<sup>th</sup> sheet is sampled (M5) and density profiles were made.

2508: no significant decay only weak decay landside 10 mm

2507 thickness app. 50 mm, no significant decay, only weak decay waterside 10 mm

2506: no significant decay, only weak decay behind a thin hard layer in 5 mm

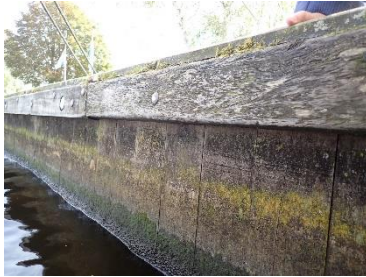
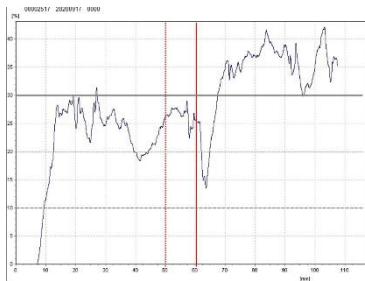
AB upper part (land side, approximately 15 cm from head)

Condition relative good (visible/ awl at top pile landside 5 mm decay, density profiles show only weak decay in the middle parts, most prominent in the upper 250 mm); the same sheet pile is sampled (M6) as from which the density profiles were made.

2517: no significant decay, only weak decay in middle 10 mm.

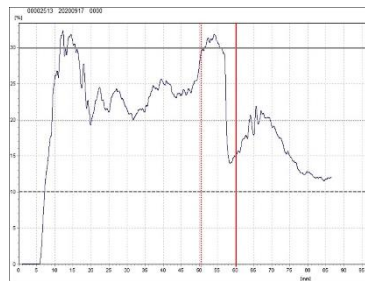
HV just below purlins (water side, 30 cm from head)

2513: thickness appr. 50 mm; no significant decay, only weak decay in middle 10 mm.

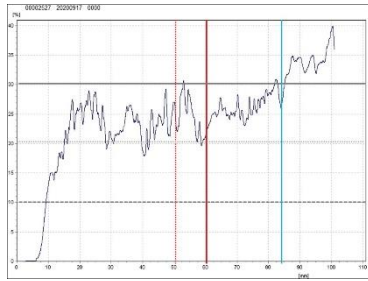
AB upper part (land side, approximately 15 cm from head)

Sheets piles 1d, tali, next after 1c sheet piles are located between pole 15 and 16. Thickness at least 40 mm. Condition relative good (visual no decay, density profiles moderate decay 10 mm deep waterside from 150 mm downwards, weak decay landside 5-15 mm top to water level, and middle top to 300 mm downwards 15 mm); the same sheet pile is sampled (M7) as from which the density profiles were made.

2527: no significant decay, only weak decay landside 5 mm and middle 15 mm

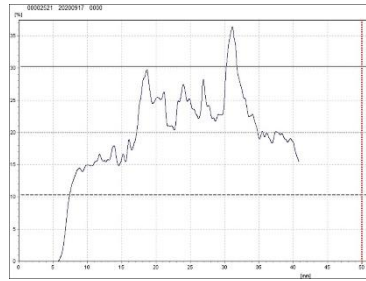
HV just below purlins (water side, 30 cm from head)

2521 thickness more than 40 mm; moderate decay waterside 10 mm, weak decay landside 15 mm and middle 15 mm

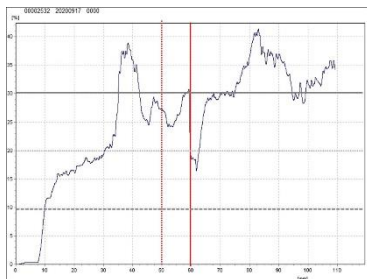
AB upper part (land side, approximately 15 cm from head)

Sheet piles 1e, okan, next few sheets piles after 1d sheet piles are located around pole 13. Thickness 50 mm. Condition relative good (visual, awl at top landside 1-2 mm decay, density profiles show weak decay in the middle and at the top landside 20 mm, and at the water level waterside 15 mm); the same sheet pile is sampled (M8) as from which the density profiles were made.

2532: weak decay landside 20 mm and middle 10 mm, rest no significant decay

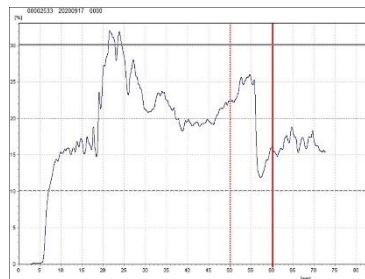
HV just below purlins (water side, 30 cm from head)

2533 thickness app. 50 mm; weak decay waterside 15 mm and middle 20 mm, rest no significant decay

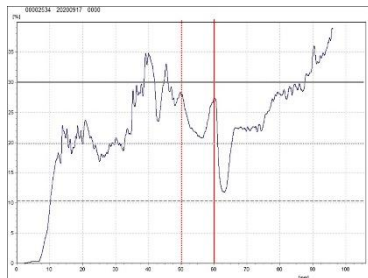
Sheet piles 1f, tali, next few sheets piles after 1e sheet piles are located around pole 9. Thickness 50 mm. Condition is good (density profiles show weak decay at waterside over whole length in 5 mm, and at the top in the middle 5 mm). The same sheet pile is sampled (M9) as from which the density profiles were made.

2534: no significant decay, only weak decay landside 5 mm, middle 5 mm (behind hard peal waterside)  
AB upper part (land side, approximately 15 cm from head)

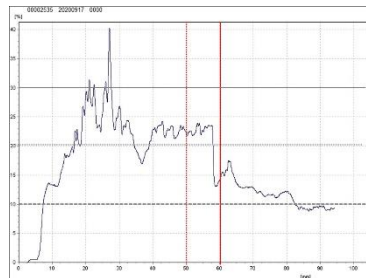
2535 thickness app. 50 mm, no significant decay, only weak decay waterside 5 mm  
HV just below purlins (water side, 30 cm from head)

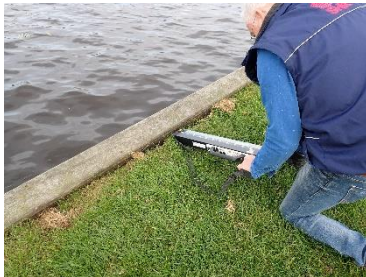
Sheet piles 1g azobé, next few sheets after 1f sheet piles are located around pole 7. Thickness 50 mm. condition questionable (visual / awl top landside white rot 30 mm deep, density profiles show moderate decay in the upper 300 mm at the landside 10-20 mm and in the middle part 15-25 mm, at the water level the decay is less weak); the same sheet pile is sampled (M10) as from which the density profiles were made.

Skewed drilling

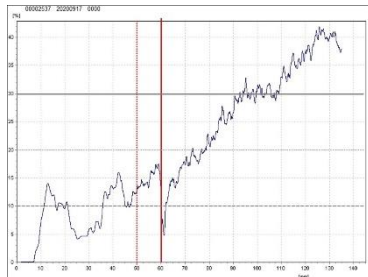
upper part (land side, approximately 15 cm from head)

2537: moderate decay landside 10 mm, middle 25 mm, weak decay waterside 15 mm

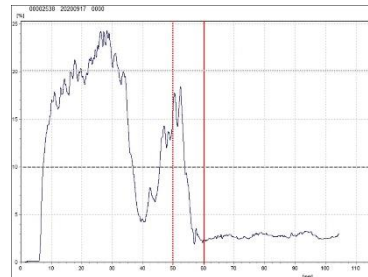
just below purlins (water side, 30 cm from head)

2538 thickness app. 50 mm, decay moderate landside 20 mm, moderate -severe middle 15 mm, rest (waterside) no significant decay 25 mm

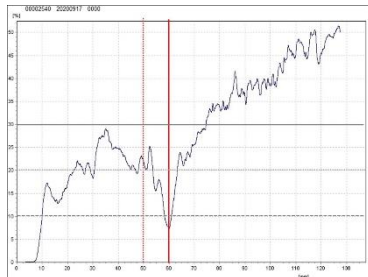
upper part (land side, approximately 15 cm from head)

Sheet piles 1h, araracanga, next few sheets after 1g sheet piles are located around pole 5. Thickness 50 mm. Condition good (visual / awl top landside superficial decay, density profiles no significant decay, only weak decay at top both land-and waterside in 5 mm, and at the water level waterside 10 mm and middle 20 mm); the same sheet pile is sampled (M11) as from which the density profiles were made; this is the last pile of this species.

2540: no significant decay, besides weak decay landside behind hard peal 5 mm, waterside 5 mm.

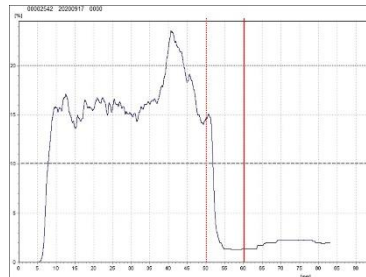
just below purlins (water side, 30 cm from head)

2542 thickness app. 50 mm, no significant decay

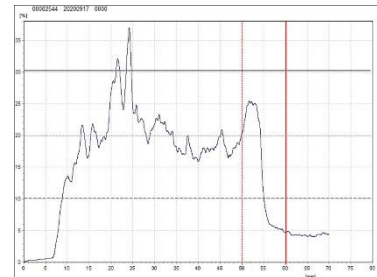
just above water level (water side)

2544: weak decay waterside 10 mm, middle 20 mm, rest no significant decay

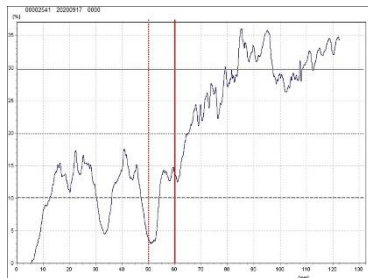
upper part (land side, approximately 15 cm from head)

Advanced stages of the decay process were found in roupala and robinia. So both roupala and robinia do not act well under these conditions for sheet piling

Thickness 50 mm. Condition bad (visual / awl top landside deeply degraded, density profiles show moderate to severe decay in large parts of the pile); the same sheet pile is sampled (M12) as from which the density profiles were made, is the first pile of this species.

2541: decay moderate to severe over whole thickness.

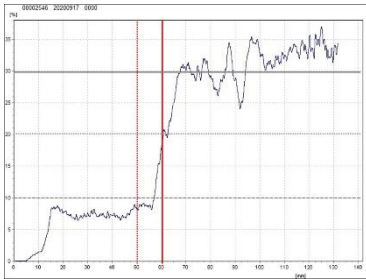
2546: decay moderate to severe over whole thickness.

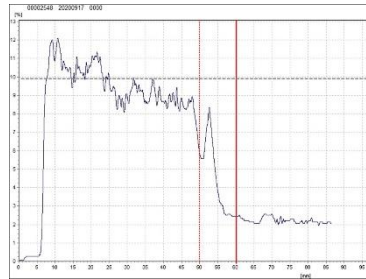
2548: decay moderate to severe over whole thickness

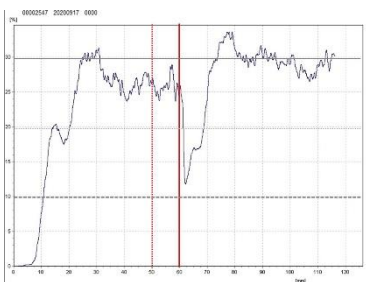
upper part (land side, approximately 15 cm from head)

2547: no significant decay, only weak decay landside 10 mm

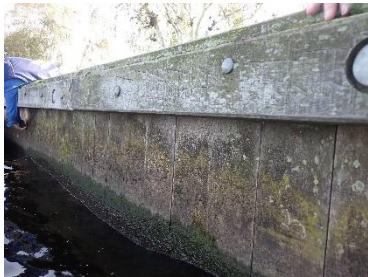
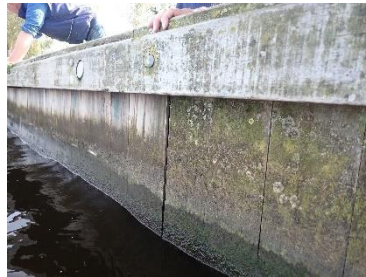
Sheet piles 2, angelim vermelho, the first 24 sheets piles along the main river pathway after the corner with the combination sheet piles 3. It is assumed that the lower parts of the sheet piles is Austrian larch, thickness 45 mm, width approximately 180 mm, rabbet 20 x 20 mm. The condition of the piles is good (no visible or with density profiles detectable decay), third sheet is sampled (M3) and density profiles were made.

Transition of the angelim vermelho -larch sheet piling to sheet pile 1a okan

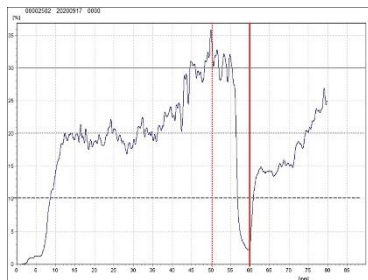
AB upper part (land side, approximately 15 cm from head)

2502: no significant decay both water and landside

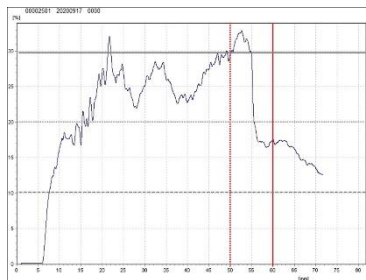
HV just below purlins (water side, 30 cm from head)

2501: thickness is app 45 mm, no significant decay both water and landside

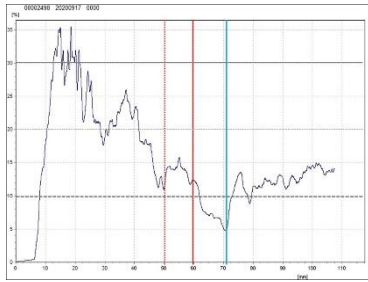
Sheet pile 3, combination sheet pile (Van Swaay), situated over the full short end of the island. The upper part is angelim vermelho, thickness 45 mm, width approximately 180 mm, rabbet depth 20 mm, 22 mm wide and the lower part is probably a softwood. Most upper parts are sound, no decay, a few upper parts show some bugling and occasionally some plant growth through the nails.. The condition of the eighth sheet from the corner with the frontside of the island, was questionable (visually degraded, density profiles show weak to moderate decay on waterside at middle) (M1, lost its smell), adjacent sheet was good (visually no decay, density profiles show weak decay in top 15 mm on landside, 10 mm middle), (M2). Both samples confirm the wood species.

2498: landside no significant decay, weak decay middle 25 mm, moderate decay waterside 10 mm

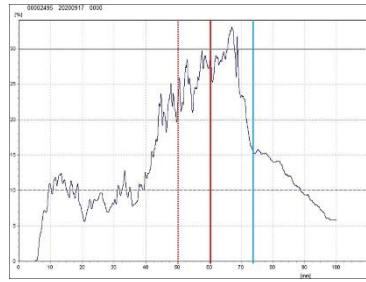
2495: no reliable thickness estimation here because of skewed measurement; landside no significant decay, weak decay middle 10 mm, moderate decay waterside 25 mm

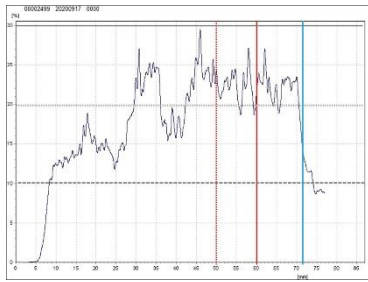
upper part (land side, approximately 15 cm from head),

2499: landside weak decay in 15 mm, 10 mm in middle, rest no significant decay

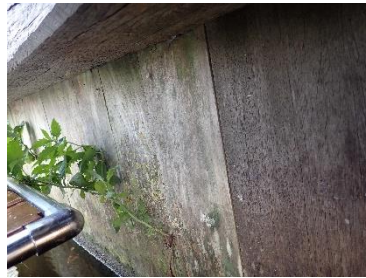
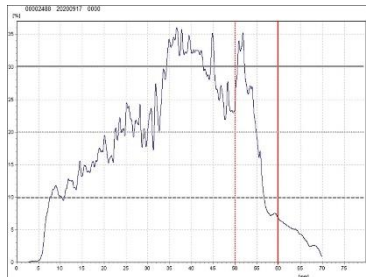
upper part (land side, approximately 15 cm from head)

2492: landside weak decay in 10 mm, rest no significant decay

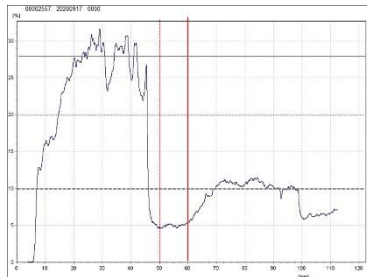
2556: no significant decay, besides weak decay landside behind hard peal 5 mm, waterside 5 mm.  
upper part (land side, approximately 15 cm from head),

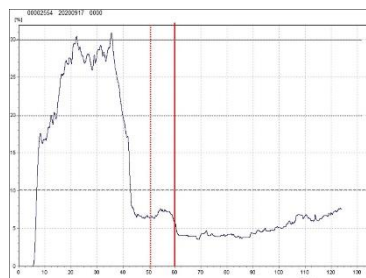
AB upper part (land side, approximately 15 cm from head)

2553: weak decay over the full thickness, hard peal waterside.

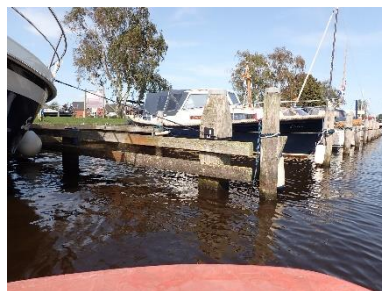
Fifth pole (MP2)

Round hardwood pole, no significant decay on and above the water line. Diameter poles approximately 22 cm. The density profile taken approximately 20 cm above the water line, shows a degraded outer most sheet of 20-30 mm. Wood sample (MP2) was taken.

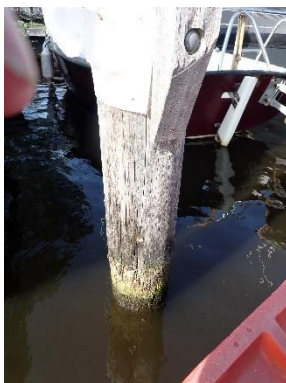
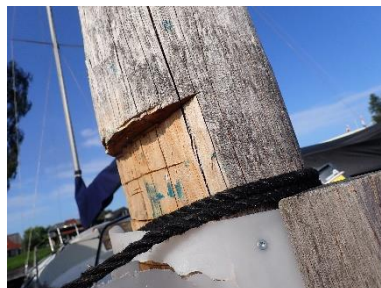
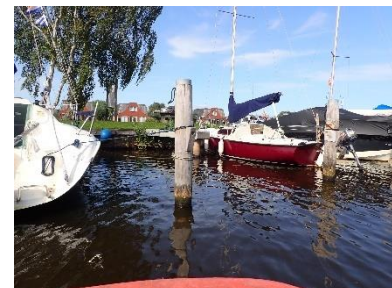
Left picture: 6<sup>th</sup> pole from the corner

No remarks, from the 6<sup>th</sup> pole a slice of wood was removed above the water level. From the 11<sup>th</sup> pole above the water level wood sample MP5 was taken.

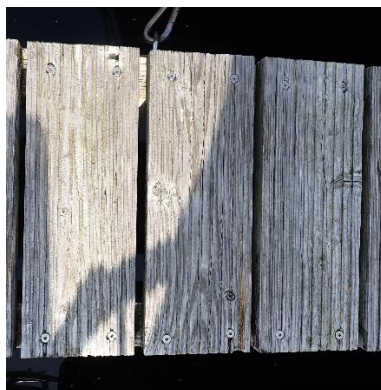
Board 1-4

Landing stage 5 larch in all, gang boards, horizontal construction beams and pole. The gangboards are positioned with the heart side above, always. The gang boards and the horizontal construction beams are approaching their end of life stage, because of decay. In the gang boards the decay is mainly around the screws (especially at the 1<sup>st</sup>, 7<sup>th</sup>, 14<sup>th</sup>, 15<sup>th</sup>, 16<sup>th</sup>, 17<sup>th</sup> and 18<sup>th</sup> gang board). Because of the degradation, the screw connection is less tight and all boards can move somewhat compared to the horizontal beams. Also decay is found in the horizontal beams, where it is local and extending from the horizontal surface downwards. The condition of the pole is good above and below the water line, on the water line a 5 mm thick layer of weak decay is present only.
